THE DOCUMENTATION OF CULTURAL HERITAGE SITES IN CYPRUS USING INTEGRATED TECHNIQUES: THE CASE STUDY OF THE CHURCH OF AGIOS ATHANASIOS AND KYRILLOS

Kyriacos Themistocleous[a,b], Evagoras Evagorou[a,b], Christodoulos Mettas[a,b],
Maria Prodromou[a,b] & Diofantos Gl. Hadjimitsis[a,b]

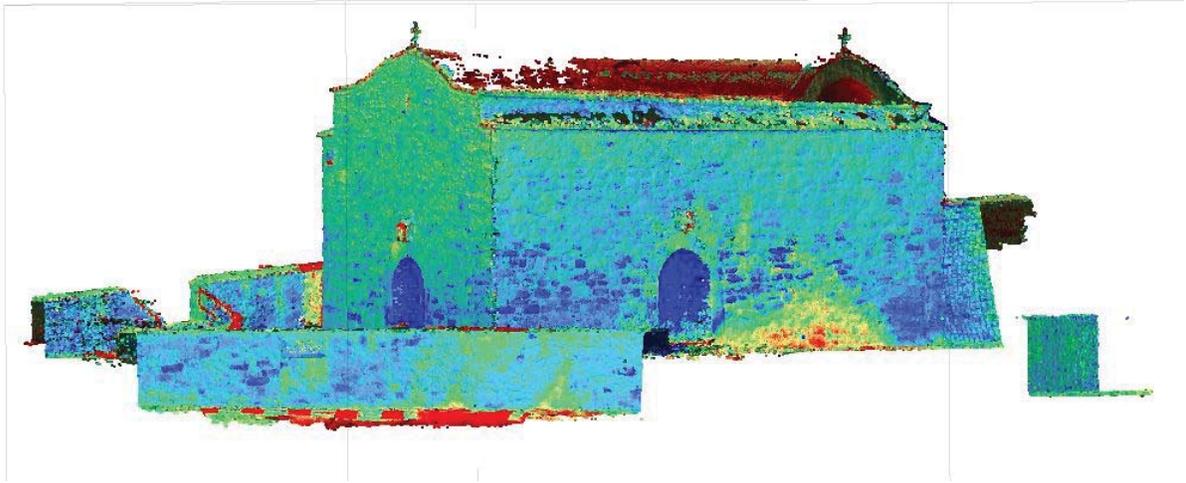
Figure 6: Church 3D model point cloud generated after the use of the LCI using the blue and near infrared channels
from the multi spectral camera

Once the LCI equation was applied to the 3D point cloud model of the blue and near infrared channel taken from the multispectral camera, it was evident that there were red markings which were indicative of a high level of moisture within the masonry wall. This is evident in Figure 1, where the high moisture level on the outside of the church caused damage to the frescoes on the corresponding inside part of the church.

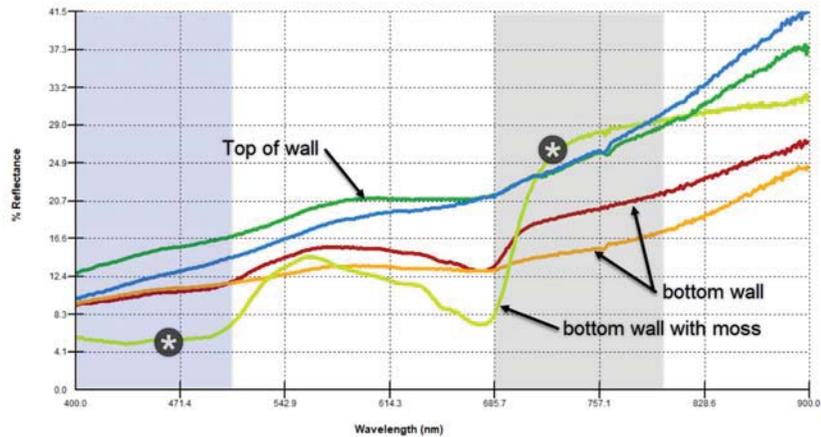
Figure 7: Spectral signatures of the church

In order to identify the behavior of the stone wall within various conditions, such as stone with moss, stone with pitting, stone without moss, a SVC 1024 spectroradiometer was used to obtain spectral signatures (400–2500 nm) from the wall to study the different areas. The spectral signatures obtained (figure 5) indicated a low reflectance value at the blue band (400-500 nm) and a high reflectance value at the near infrared band (700–800 nm). The multispectral camera Canon SH260 uses three bands with blue (400-500 nm), green (500-600 nm) and near infrared (680–800 nm). Since the spectral signatures of the walls showed a low reflectance at the blue channel and high reflectance at the near infrared channel, only the blue (400-500 nm) and near infrared (680-800 nm) band were used in order to create a 3D point cloud using the images from the multispectral camera.

The spectral peak from the blue channel from the SH260 camera was at 470 nm and from the near infrared channel was at 720 nm, as shown in figure 7. Therefore, the following equation was applied to the 3D model (equation 2)

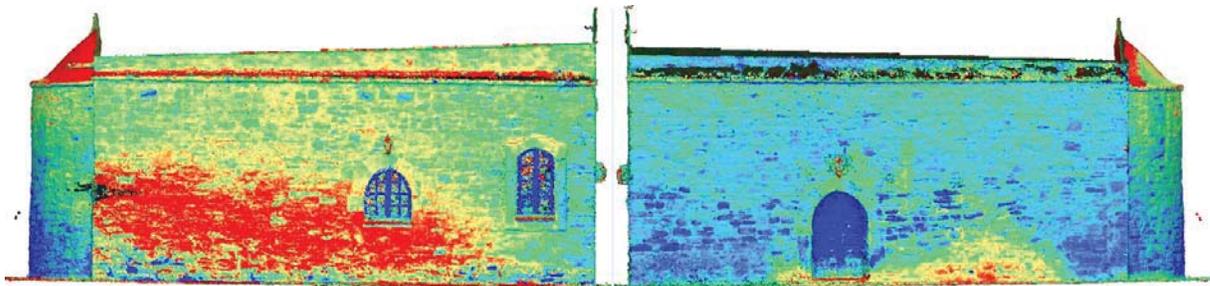
Figure 8: Left: North view of church; Right: South view of the church
LCI using Multi-spectral showing moisture in red color

The LCI equation using multispectral imaging showed high levels of moisture (indicated in red) in the masonry at the north and south areas of the church, as shown in figure 8 below.

Similar techniques were used by Del Pozo [1], where the presence of moisture in a structure was identified through the analysis and processing of multispectral data from multiple sensors. The results of this methodology can be used for early detection of moisture in order to minimize the degradation of cultural heritage sites. Since each material has a unique reflectance behavior depending of the wavelength, the presence of pathologies on walls, such as moisture that can generate moss is likely to be successfully detected by analyzing the reflected visible and near infrared radiation from the wall reflectance, which indicate that the pathologies are derived primarily from moisture. The results from the LCI index show that the moisture that is collected on the ground outside of the church is resulting in moisture being absorbed by the wall and penetrating the church walls in the interior of the church and destroying the frescos. In order to terminate this damage, an extensive restoration needs to be conducted in order to remove and stop the moisture by penetrating the church walls.

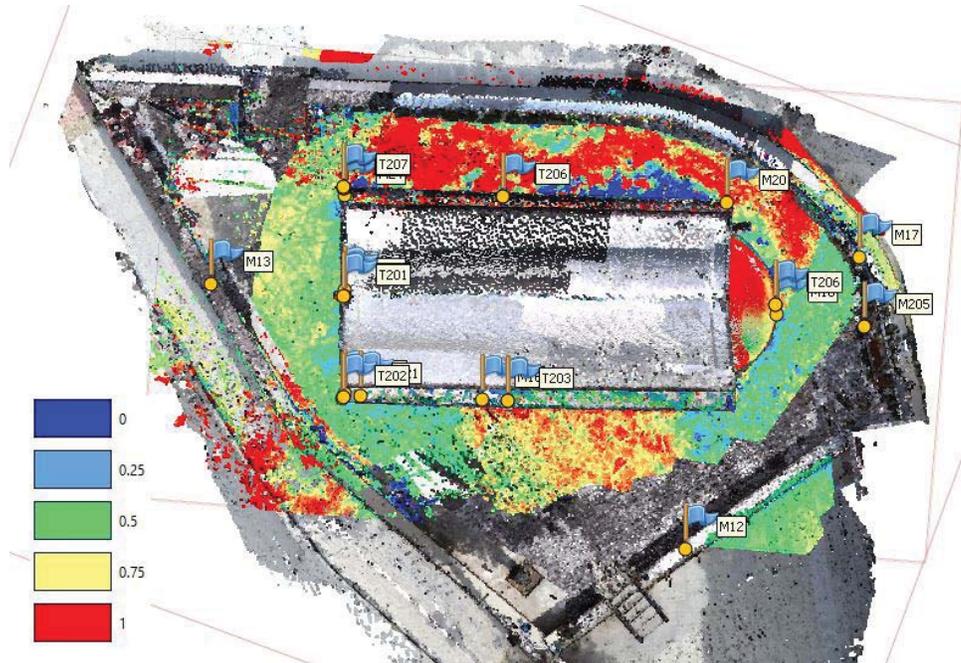
Figure 9 features the aerial image of the church with geo-reference GCPs while Figure 10 features the church from two different angles. The images were generated by combining the results of the laser scanner and multispectral images processed using photogrammetry. The legend at the left side of the image indicates the amount of moisture present on the church grounds and the walls of the church. As is evident, the red sectors of the image indicate higher moisture levels.

Figure 9: Ortho-image site plan of the Church using a combination of laser scanner, RGB and multispectral images processed using photogrammetry
